CAPSULE SUMMARY
Seneca Creek State Park
MIHP # M:19-38
Gaithersburg vicinity
Montgomery County, Maryland
Park = 1955
Public

SENECA CREEK STATE PARK

MIHP # M:19-38

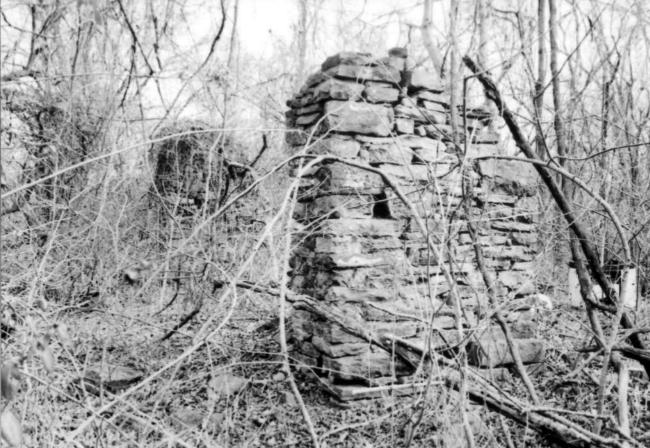
M 19-38 Seneca Creek 3P Montgomeny Co Md RCGA 2-3/03 Md SHPO John Padget Farm site (M:17-51), house foundation, was E. 3/40

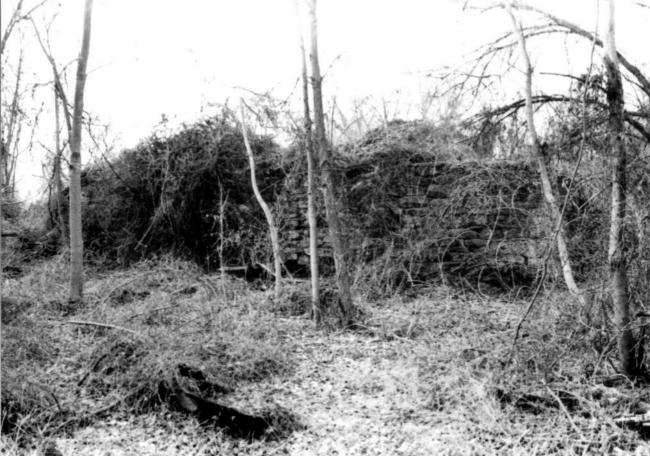
M 19-38 Seneca Creek SP Montgomery Co Md RCGA 2-3/03 Md SHPO Charles Allaut House Ste (M17-55) barn foundation view Sw 4/40

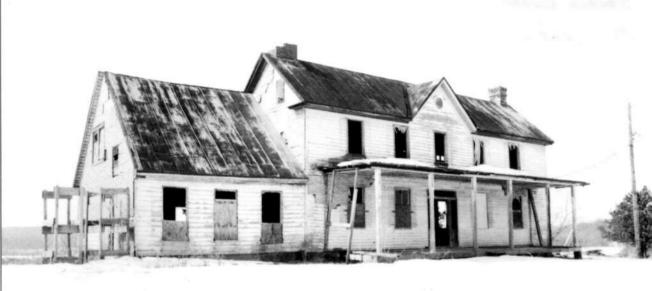
M 19-38 Seneca Creek SP Montgomeny Co Md RCGA 2-3/03 Md SHPO Americus Dawson House (M 18-27) view NW 6/40

The ca. 1860, wood-frame, two-story Americus Dawson House is a T-shaped plan with additions on the rear (west) and south elevations (Figure 6). The building rests on a stone rubble foundation. The mortise-and-tenon walls are clad with wood clapboard. The cross gable roof is sheathed with standing seam metal. The roof features gable returns. Interior, brick, chimneys are located at the gable ends. The front (east) façade of the main block has a full-width porch with chamfered wood posts. The porch shelters a central entry. The door is flanked by sidelights and topped with a transom. The south addition is a one-story, wood-frame building resting on a stone rubble foundation. The walls are clad with wood clapboard covered by tarpaper. The side gable roof is sheathed with standing seam metal. The two-story rear addition also rests on a stone rubble foundation. The mortise-and-tenon wood-frame walls are clad with wood clapboard. The gable roof is sheathed with standing seam metal. The Americus Dawson is in poor condition. Several doors and windows are missing and the roof is rusted. Restoration has begun and the foundation has been stabilized and repointed.

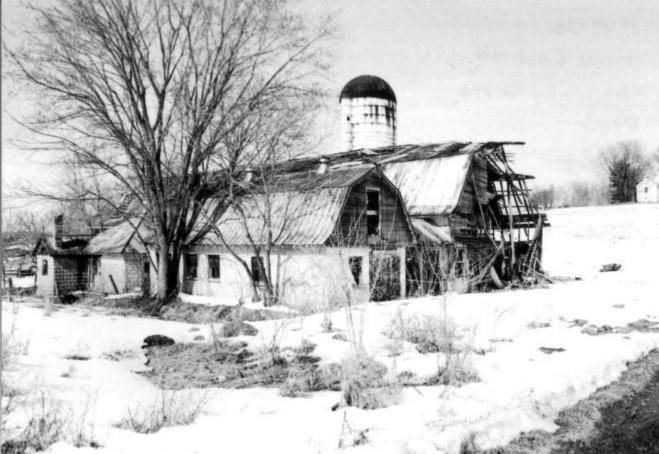
M:19-38 Seneca Creek SP Montgomen Co Md RCGA 2-3/03 Md SHPO Americus Dawson Farm Complex (M18-27) view Hlo 7/40

The ca. 1925 Americus Dawson Dairy Barn faces east onto the farm lane (Figure 7). The two-story, wood-frame building rests on a concrete-block foundation. The walls are clad with wood clapboard. The gambrel roof is clad with standing seam metal. The building is in poor condition. The building has

The ca. 1925 Americus Dawson Dairy faces east onto the farm lane (Figure 7). The one-story concrete-block building rests on a concrete slab. The building terminates in gambrel roof with exposed rafters. The roof is clad with standing seam metal. The windows are two-light-over-two-light, metal-sash units with concrete lug sills. The building is in poor condition. The concrete foundation has settled and the walls have cracked and sections of concrete are missing. Most of the windows are broken and the roof is rusted.

The ca. 1920 Americus Dawson Old Dairy faces east towards the new dairy (Figure 7). The one-story, rectangular, rusticated concrete-block building rests on a concrete slab. The pyramidal roof is clad with corrugated metal and features a ventilator. The windows are six-light-over-six-light wood-sash units. A small gable roof addition is appended to the south elevation. The addition has a rusticated concrete-block chimney. The building is in poor condition. The floor has sagged and walls are cracked. Most of the windows and the doors are no longer extant and the roof is rusted.

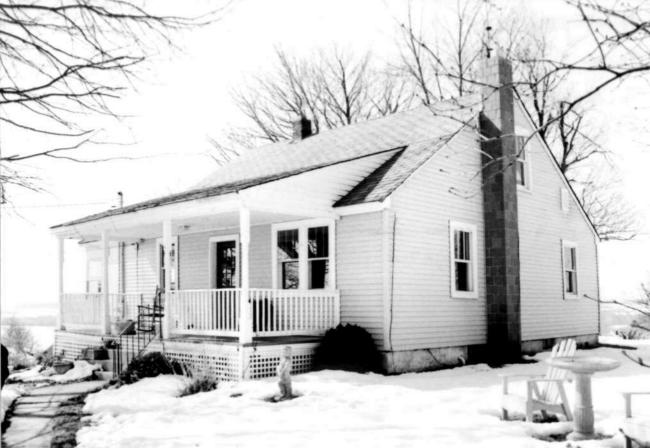
Seneca Creek SP Montgomeny Go Md RCGA 2-3/03 Md SHPO Americus Dawson Bungalow (M18-27), view 5. 8/40

The ca. 1930 Americus Dawson Bungalow is located near Schaeffer Road and faces east onto the farm lane (Figure 8). A one-story, wood-frame addition is appended to the south elevation. The one-story, three-bay, wood-frame house rests on a concrete-block foundation. The walls are sheathed with vinyl. The gable roof is clad with asphalt shingles. The building has an exterior gable end, concrete-block chimney on the north elevation and an off center, brick chimney located on the ridge. The building features three-light-over-one-light, wood-sash windows and a central entrance. The entrance features a nine-light, two-panel, wood door. A full-width, three-bay, shed roof porch protects the entrance. The porch supports are turned wood spindles. The house is in good condition.

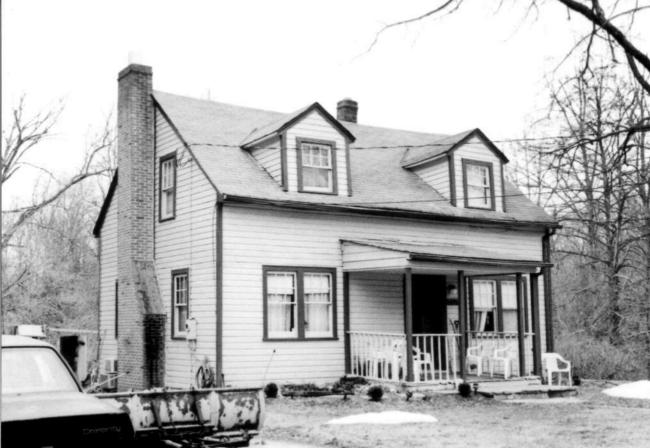
M 19-3B Seneca Creek SP Montgomery Co Nd RCGA 2-3/03 Md SHPO National Capital Skeet & Trap Club Formhouse, view St. 9/40

The NATIONAL CAPITOL SKEET AND TRAP CLUB FARMHOUSE is located at 16700 Riffle Ford Road. The building is a one-and-one-half-story, three-bay, wood-frame house built ca. 1925 (Figure 9). The building has a rectangular footprint and rests on a concrete-block foundation. The walls are clad with wood clapboard and the side gable roof is sheathed with asphalt shingles. Two gable dormers are located

on the front and rear elevations. The windows are six-light-over-one-light, double-hung, wood-sash units with simple wood surrounds. The central front entry features a stoop and shed roof hood. Wood posts support the roof. The front entry is six-panel, wood door with a fanlight. The house is in good condition.

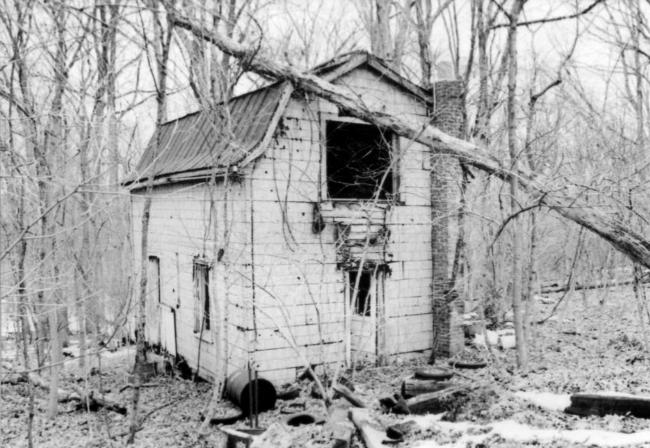
M 19-38 Seneca Creek SP Montgomen, Co Md RCGA 2-3/03 Md SHPO National Capital Skeet & Trap Club 10/40

The ca. 1925 National Capitol Skeet And Trap Club Tenant House is a one-and-one-half-story, one-bay, wood-frame building (Figure 10). The building occupies a square footprint and rests on a concrete-block foundation. The walls are clad with asbestos shingles and the gambrel roof is sheathed with corrugated metal. The house has an external, brick chimney on the front elevation. Evidence exists that the windows were double-hung wood-sash units with wood surrounds. The centered front entrance has a four-light, three-panel, wood door. The house is in poor condition. The wood frame and window and doorframes are rotted and the windows and doors are missing or vandalized. The roof is rusted.

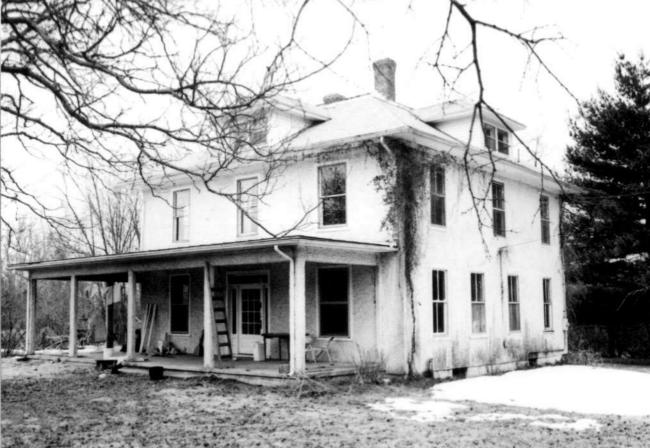
M: 19-38 Seneca Creek SP Montgomeny Co Md RCGA 2-3/03 Md SHPO Button Property (M18-43) House, view SW

The BUTTON PROPERTY (MIHP #M:18-43) is located on the west side of Black Rock Mill in Seneca Creek State Park. The ca. 1905 farmstead includes a farmhouse, a garage, a privy, a hay barn, an animal trough, and a cemetery. The BUTTON HOUSE is a ca. 1905, two-story, three-bay, four square design and faces east (Figure 11). The wood-frame house occupies a square footprint and rests on a stone rubble foundation. The walls are clad with stucco and the hip roof is sheathed with asphalt shingles. Gabled dormers are located on the front and side elevations. Two brick chimneys project from the roof. The windows are two-light-over-two-light, double-hung, wood-sash units. The central entrance features a twelve-light, single-panel wood door flanked by sidelights and topped by a transom. A full-width porch wraps around the front and left side elevations. Stuccoed square posts support the porch's flat roof. The building is in fair condition. The wood sills have rotted causing the walls to settle and the stucco to crack. In addition, portions of the stone foundation are failing.

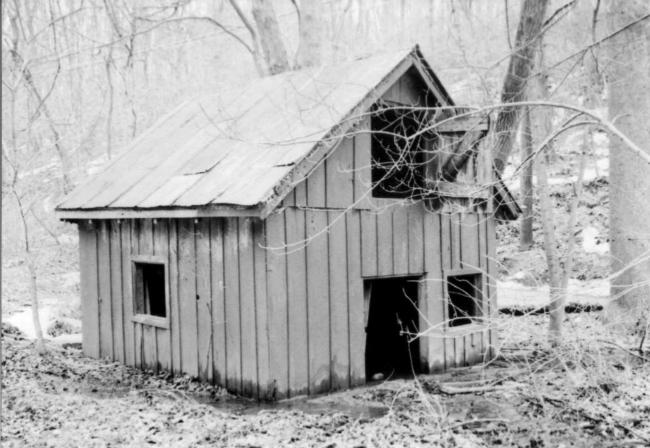
M 19-38 Genera Creek SP Montgomen Co Md RIGA 2-3/03 Md SHPO Animal Pen, ow NE Warneking 13/40

The WARNEKING ANIMAL PEN is a ca. 1960 one-story, square building located in a streambed next to Blackrock Road. The wood-frame building is clad with board-and-batten siding and the front gable roof is sheathed with corrugated metal (Figure 13). The low door opening is located on the front (south) elevation and window opening are located on the south and west elevations. The building is in poor condition. The building rests in a streambed, which contributes to the rotting of the frame and siding.

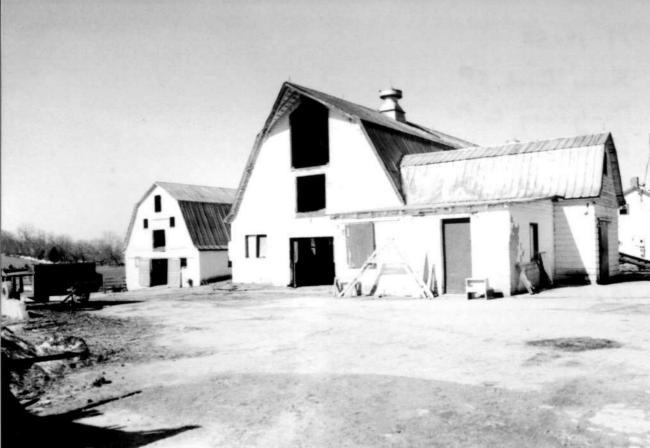
A number of individual farm complexes and agricultural resources exist in the Schaeffer Farm section in the park including: the Americus Dawson House (MIHP #M:18-27), Button Property (MIHP #M:18-43), Savage Farm (MIHP #M:18-50), and Warenking property. The Americus Dawson House is a large residence undergoing restoration as part of the MdDNR's curatorship program. At the time of the site visit, the house was in poor condition, character-defining windows and doors had been removed, as well as most interior walls and floors. The house no longer retains agricultural buildings from the nineteenth century. The associated outbuildings are in varying states of disrepair. The Pennsylvania Bank barn has collapsed and the dairy barn

has partially collapsed. The original design of the old dairy has been altered by an addition. All the equipment from the agricultural buildings has been removed. At the time of the site visit, the farm consists of a series of building shells in poor condition. These buildings do not exhibit the qualities of architectural significance for their types, periods, or methods of construction; for high artistic value; or, for association with work of a master. The house and outbuildings do not possess the significance or integrity to be eligible for the National Register of Historic Places.

M 19-38 Sures Crek SP Montgomen Co Md RCGA 2-3/03 Md SHPO Savage Farm Complex, view sw

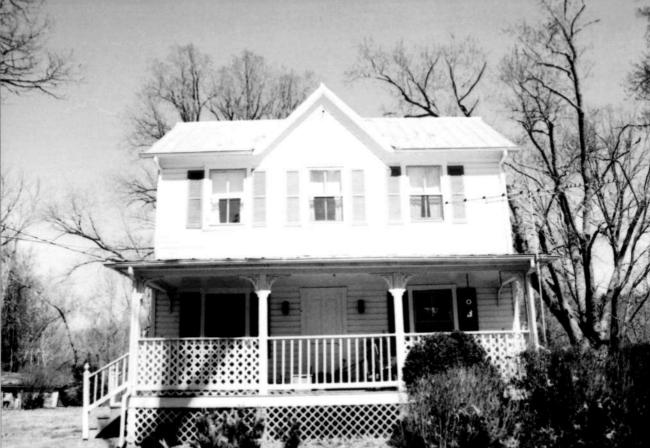
The Hunter Davidson Farm (MIHP #M24-33) is a good example of a vernacular, turn of the century farmhouse. The property includes and assortment of early twentieth century outbuildings including a shed, garage, spring house, and barn. The complex is in good condition, it retains its integrity, and it was associated with the Seneca community. The farm possesses the qualities of significance necessary for listing as a contributing element of the Seneca Historic District.

M 19-38 Seneca Creek SP Mortgomeny Co Md RCGA 2-3 /03 MY SHPO Hunter Davidson Farm (M24-33) House, view NE 17/40

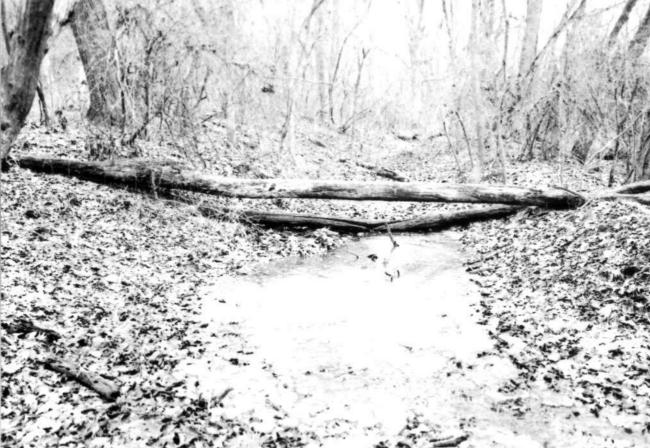
M 19-38 Seneca Creek SP Montgomeny Co Md 2-3/03 NO SHPO Senera Mill Headrace, view NE 22/40

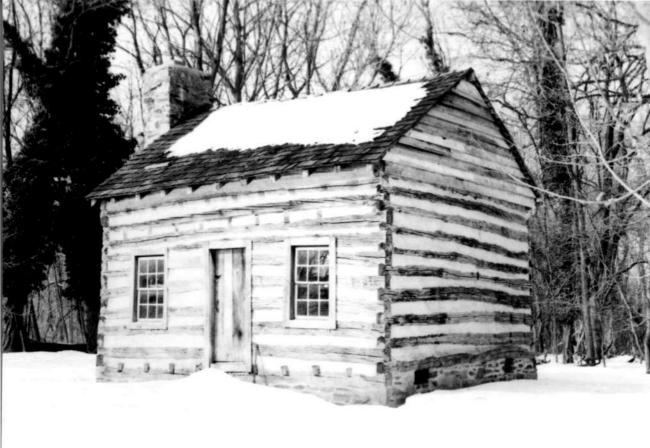
Two single-family dwellings date to the nineteenth century: the Grusendorf Log house (MIHP #M:19-38) and the Benjamin W. Allnut house. According to the MIHP, the Grusendorf Log House was relocated to the park in 1994, entirely reconstructed, and is currently used as an interpretative center. The Benjamin W. Allnut house is located in the woods on the park's periphery. The building appears to have been abandoned for a least fifty years and is in a severe state of decay. The buildings do not possess a significant association with important events (Criterion A) or with significant persons (Criterion B). The buildings do not possess signifiance for its design or construction (Criterion C). Neither building appears to have the significance or integrity for the listing in the National Register of Historic Places.

M19-38 Seneca Creek SP Montgomery 6 Md RCGA 2-3/03 Md SHPO Grusendorf Log House (M 19-38) view W. 27/40

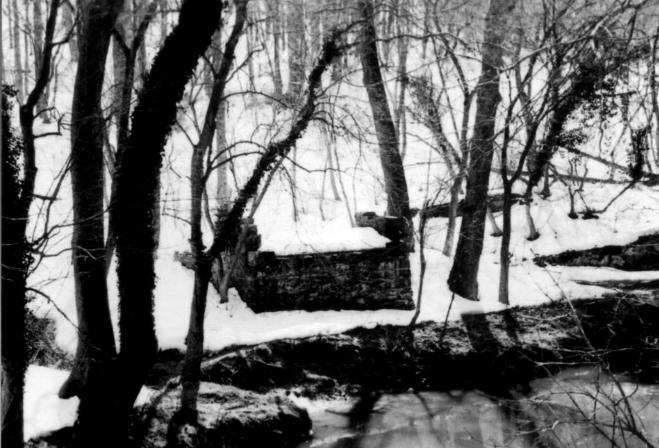
M 19-38 Seneca Creek SP Montgomeny Co SP RCGA 2-3 /03 Md SHPD Clopper Road Bridge Abutments, view E 38/40
